MARINE ENVIRONMENT PROTECTION  
COMMITTEE  
82nd session  
Agenda item 4

MEPC 82/INF.40  
26 July 2024  
ENGLISH ONLY  
Pre-session public release:

## HARMFUL AQUATIC ORGANISMS IN BALLAST WATER

### Findings from a study to evaluate the performance of ballast water management systems installed on board ships against the regulation D-2 standard of the Ballast Water Management Convention

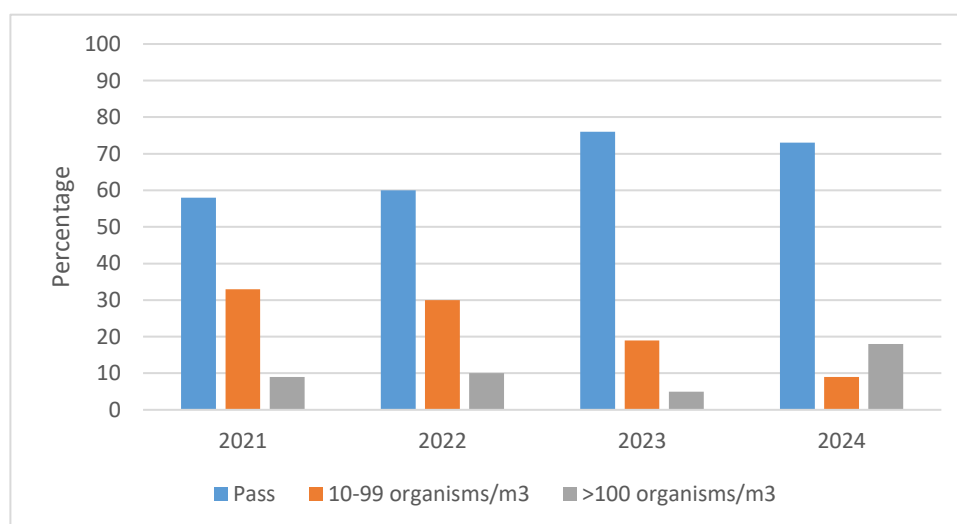
**Figure 1: Levels of compliance for  $\geq 50 \mu\text{m}$  size class organisms across 2021-2024 samples**

14 Although the proportion of non-compliant samples has generally decreased over time, sampling in 2024 had greater gross ( $>100$  organisms/m<sup>3</sup>) non-compliance than vessels in 2021-2023 (data presented in MEPC 81/INF.6) (Figure 1). Of the ships with gross exceedances, two had undertaken a mid ocean exchange (and the BWMS was used during the exchange), one had bypassed the BWMS due to safety reasons, and the other ship indicated that the BWMS had been bypassed (due to CWQ) at previous ports, although not on this voyage. Also, it is important to note that the same vessels were not necessarily sampled across the sampling years. Therefore, figure 1 cannot be interpreted to mean that a particular ship's ballast water, or its appropriately installed BWMS, has improved its performance to the regulation D-2 standard over time.
