MARINE ENVIRONMENT PROTECTION COMMITTEE
81st session
Agenda item 4

MEPC 81/INF.6
21 December 2023
ENGLISH ONLY
Pre-session public release: ☒

HARMFUL AQUATIC ORGANISMS IN BALLAST WATER

Findings from a study to evaluate the performance of ballast water management systems installed on board ships against the D-2 standard of the Ballast Water Management Convention

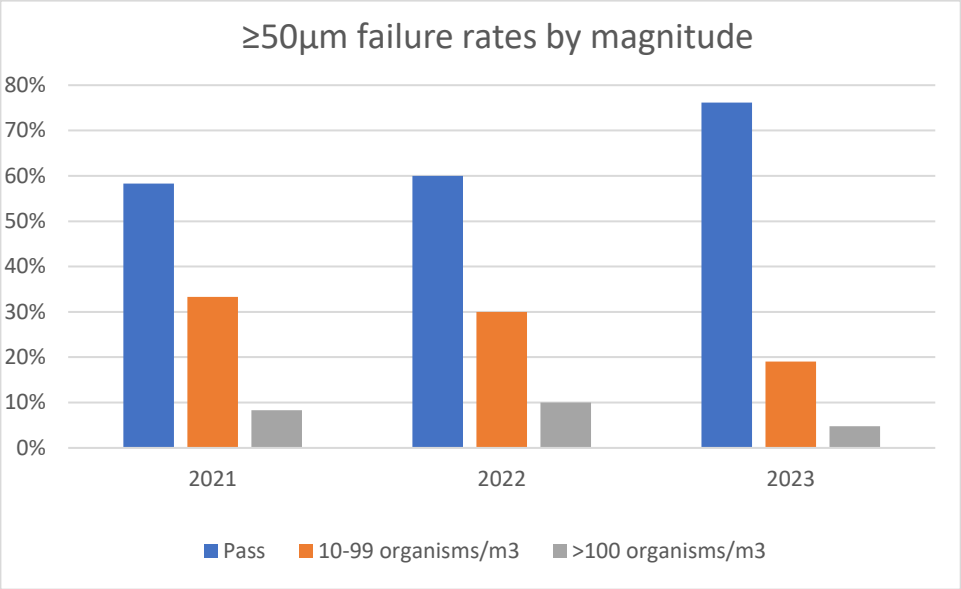
11 Across the three years of sampling, the percentages of non-compliant samples have generally decreased, especially within the gross level of non-compliance (>100 organisms/m^3) (figure 1).

Figure 1: Levels of compliance for >50µm size class organisms across 2021-2023 samples

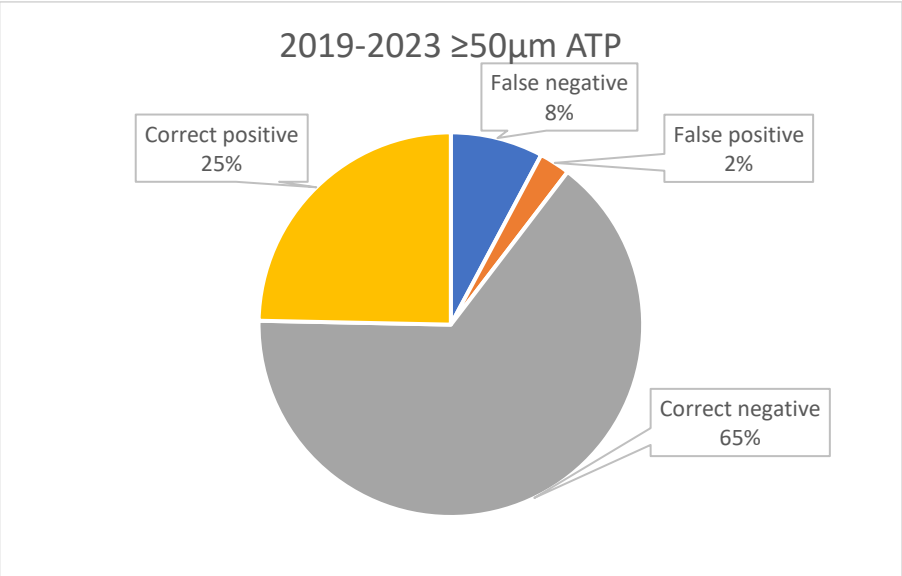
13 To assess the ATP trends over a larger data set, all of the data collected from 2019 to 2023 were analysed, totaling 77 BWMS sampled. Figure 2 compares the ATP results (indicative analysis) with the detailed analysis results in the ≥50 µm size class.

Figure 2: Comparison of ATP indicative analysis results with detailed analysis results for ≥50 µm size class for samples collected from 2019 to 2023

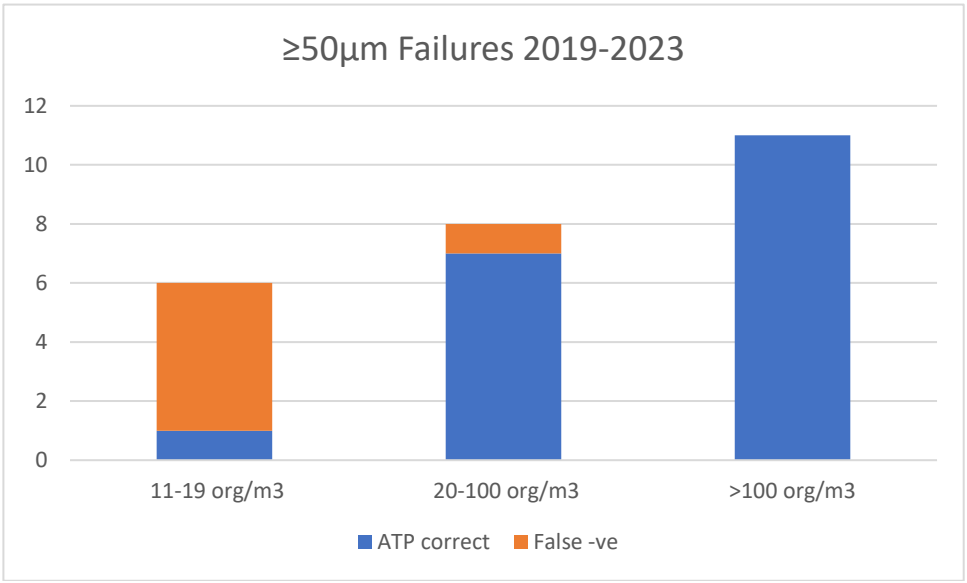
14 Focusing on the false negative results as a potential biological risk, figure 3 details the frequency of false negatives with respect to the range of exceedance in the ≥50 µm size class. The D-2 discharge limit of 10 organisms/m^3 has been used as the basis to categorize exceedance as: minor (less than 2x the limit), moderate (between 2x and 10x the limit), and gross (>10x the limit).

Figure 3: Number of false negative ATP results across levels of exceedance

15 False negatives for minor or moderate non-compliance were common (43% of cases). This scenario presents issues from an enforcement standpoint that BWMS that are not treating ballast water within the D-2 discharge limits may be missed if relying solely on ATP without detailed examination. False positives were less common but also confirmed in both the ≥50 µm size class (5%) and the bacterial size class (20%) (data not shown).

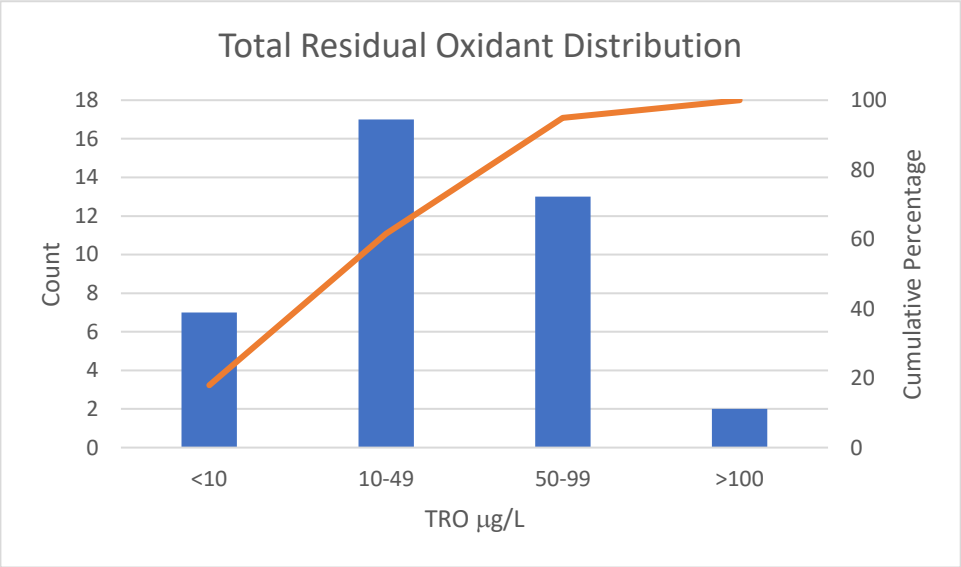
17 Of the 44 ballast water samples from 2021 to 2023, 39 were sampled from BWMS using Active Substances. Two (5%) samples were not in compliance with the Maximum Allowable Discharge Concentration (MADC) measured as Total Residual Oxidant (TRO) (0.1 mg/L expressed as Cl_2) (table 2 and figure 4). A further two ships had TRO exceedance readings at the commencement of sampling but were able to rectify the issue on board. The level of non-compliance for TRO for the 2021-2023 samples is much less than the levels reported in documents MEPC 76/INF.56 (4 of 18, 22%) and MEPC 78/4/1 (23 of 84, 27%). This decrease in TRO non-compliance is consistent with results presented in Drillet et al. (2023)*.

Figure 4: Distribution of TRO readings for 2021-2023 samples

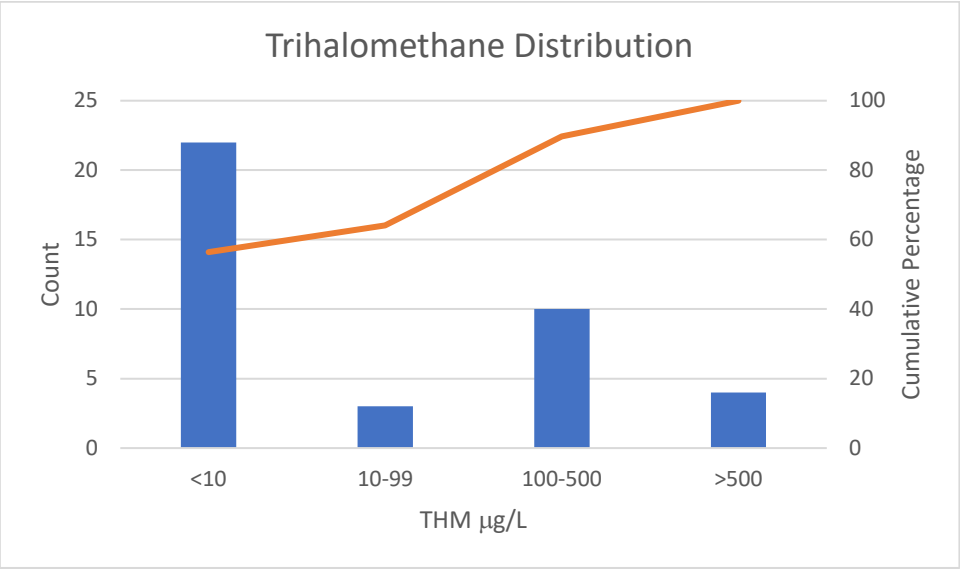
18 Measurements of disinfection by-products provided a range of measurements for total trihalomethanes (THMs) (figure 5) and haloacetic acids (HAAs) (figure 6 and table 2). Maximum Allowable Discharge Concentrations for total THMs and HAAs have not been established, but the range of concentrations recorded across the various BWMS were significantly higher than as reported in the relevant type approval documents.

Figure 5: Distribution of trihalomethane readings for 2021-2023 samples

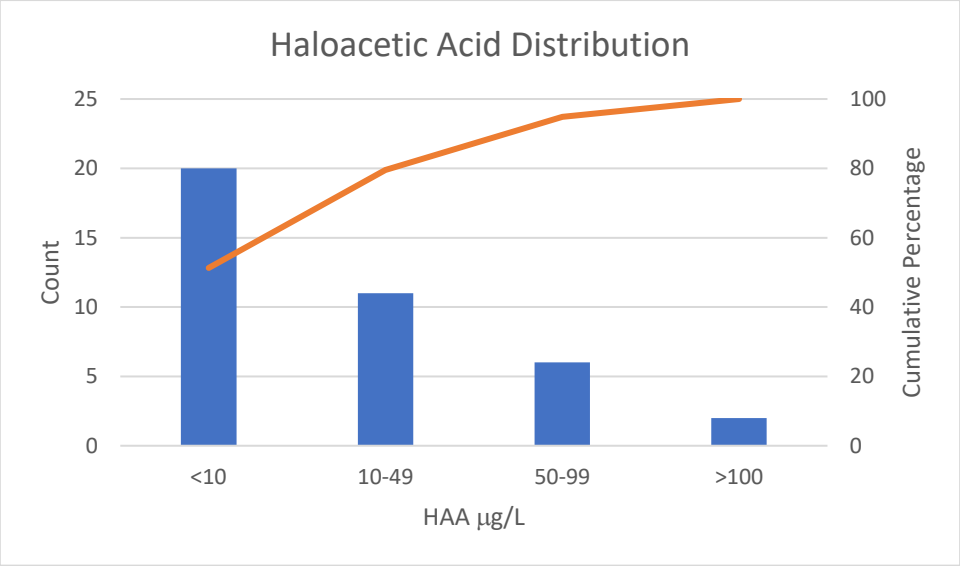
Figure 6: Distribution of haloacetic acid readings for 2021-2023 samples

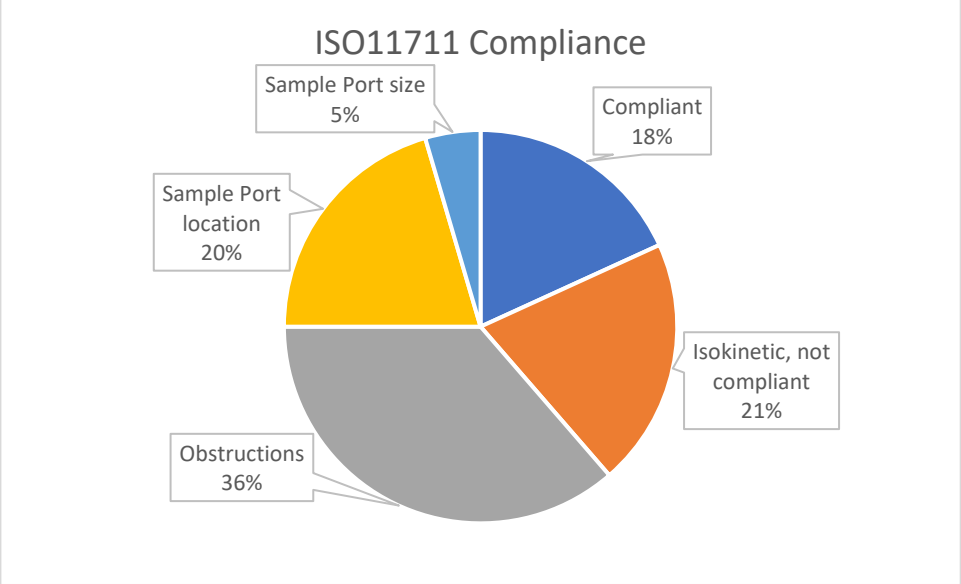
19 Of the 44 BWMS sampling ports assessed, only 8 (18%) were found to comply with the ISO 11711-1:2019 standard. Some of the BWMS samples were considered isokinetic (9 samples, 21%) but were not compliant with ISO 11711 (figure 7). The level of compliance with ISO 11711 had improved from the results presented in document MEPC 76/INF.56 where 14% were compliant.

Figure 7: Levels of compliance with the ISO 11711-1:2019 standard for BWMS sampled across 2021-2023

20 The most common factor preventing compliance with ISO11711 were inline obstructions such as elbows, T-intersections and probes located within 6x diameter of the discharge line upstream and/or 3x diameter of the discharge line downstream. Vertical issues occurred where the probe was located in a vertical section of ballast line with descending flow.
